Mill Creek

Flood Control Project
Radial Gate Investigations

US Army Corps of Engineers, Walla Walla District

HDR Engineering, Inc.

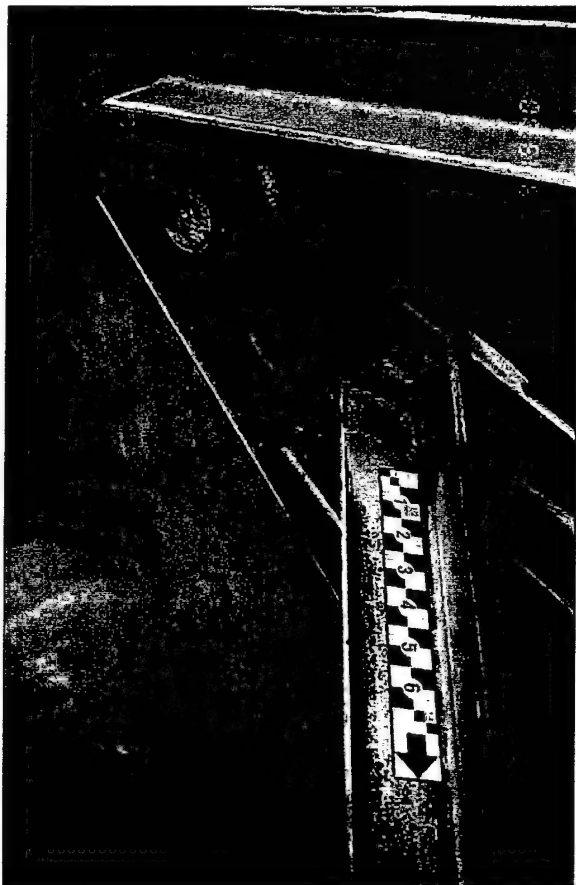
***Photo 2 - Radial strut
and diagonal brace
connection to trunnion
showing light
corrosion.***

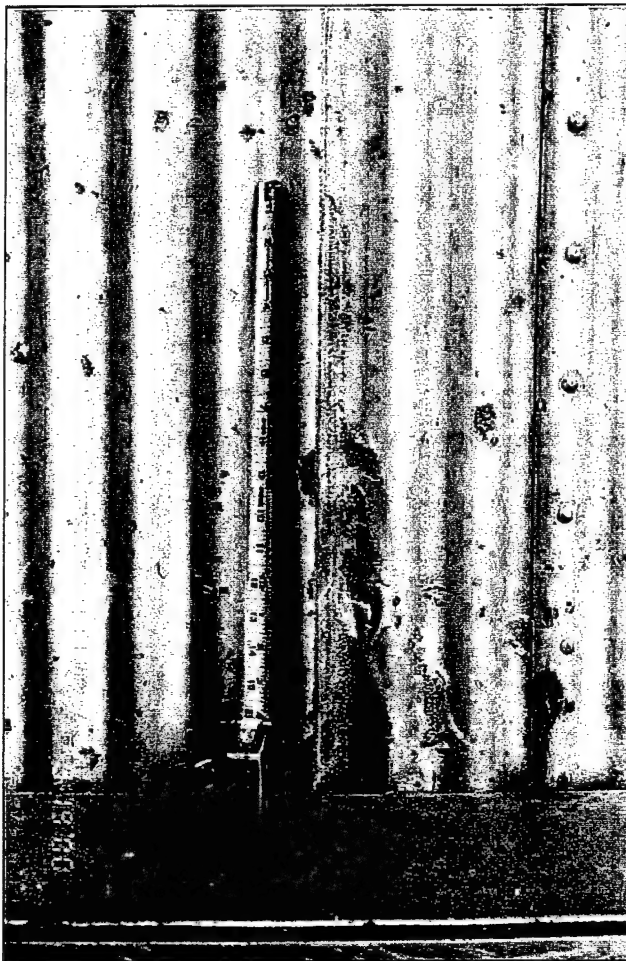
The skin plate is comprised of three sections of corrugated, galvanized steel with the corrugated ribs running in the vertical direction. The plate is $\frac{3}{32}$ inch thick, with a span between corrugations of 2- $\frac{3}{4}$ inches and a section depth of $\frac{3}{4}$ ". The skin plate is in very good condition. There are spots of delaminated paint, however, very little corrosion is visible through the galvanizing.

Photo 3 - Downstream surface of skin plate showing typical worst case delamination.

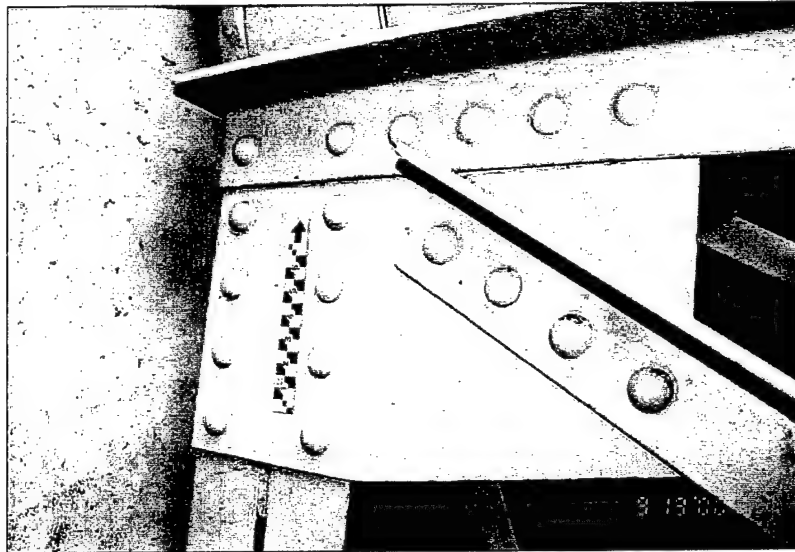
All of the connections on the gate were in very good condition. Small amounts of rivet head loss due to corrosion were found at isolated locations, however, the rivets were in generally excellent condition.

Photo 7 - Typical condition of rivets.

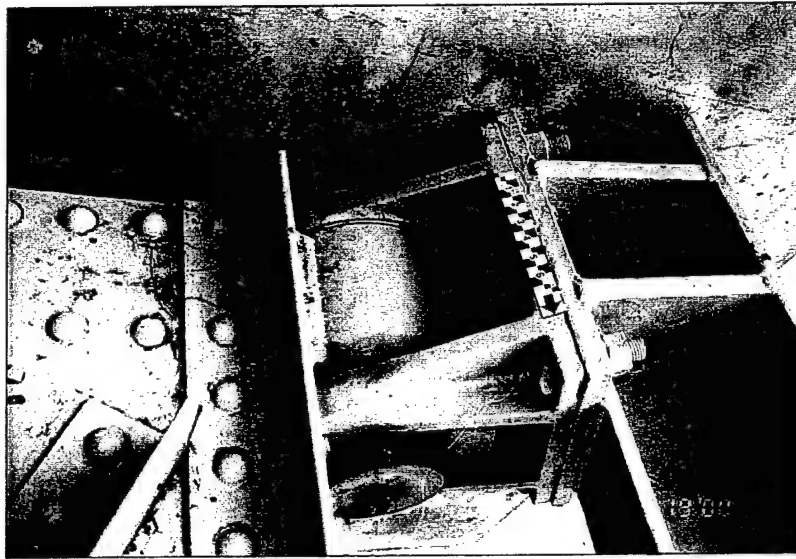
The trunnions at all of the gates are in generally good condition and appear well lubricated. There are isolated spots of light surface corrosion on the trunnion hub or yoke at some of the trunnions, however, no section loss is visible. Photo 8, below, shows the typical condition of the trunnions.

Photo 8 - Typical condition of trunnion.

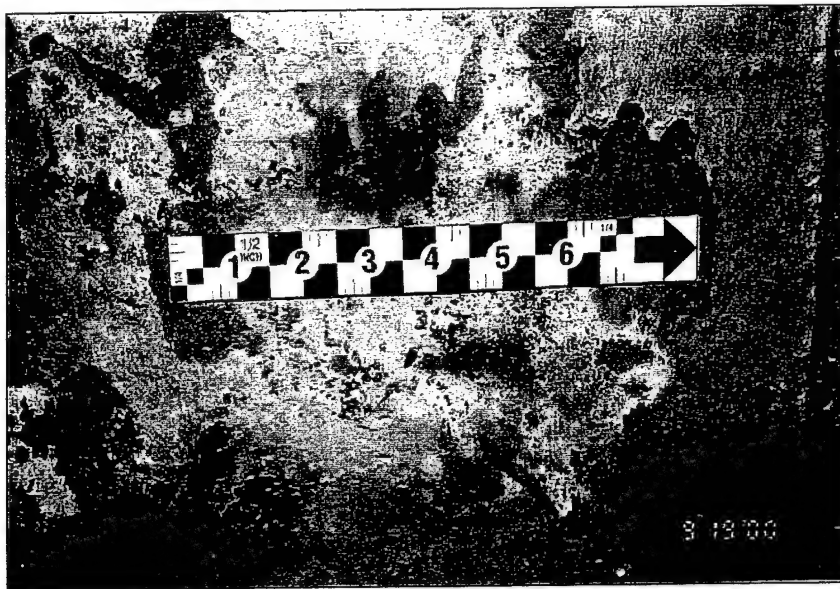
Photo 11 shows a close-up of the delaminated paint and moderate corrosion typical on the gate faces. Photo 12 shows a close-up of moderate corrosion near the bottom seal on Gate 2 (Note: good condition of rivets and bolts).

Photo 11 - Delaminated paint and light to moderate corrosion, typical on all gates.

- The exposed metal edges of the new drain holes should be spot painted.
- Spot waterblast cleaning and painting should be performed at locations of light to moderate corrosion.

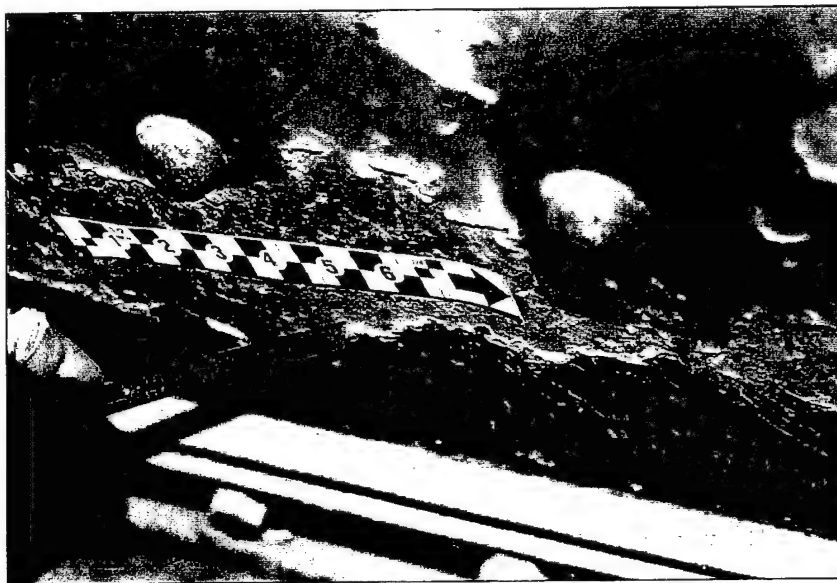
Photo 12 - Moderate corrosion on skin plate at bottom seal.

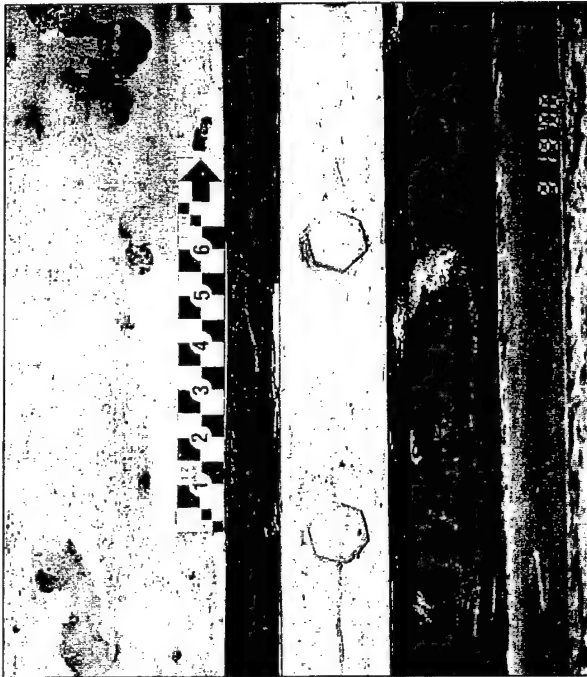
The side and bottom seals are in good condition with only light cracking and deterioration evident. Due to the water level below the spillway, no determination of leakage was possible. There is no evidence of excessive corrosion on the members likely to be caused by side seal leaks.

Photo 13 - Typical condition of side seal as seen from upstream side of gate.

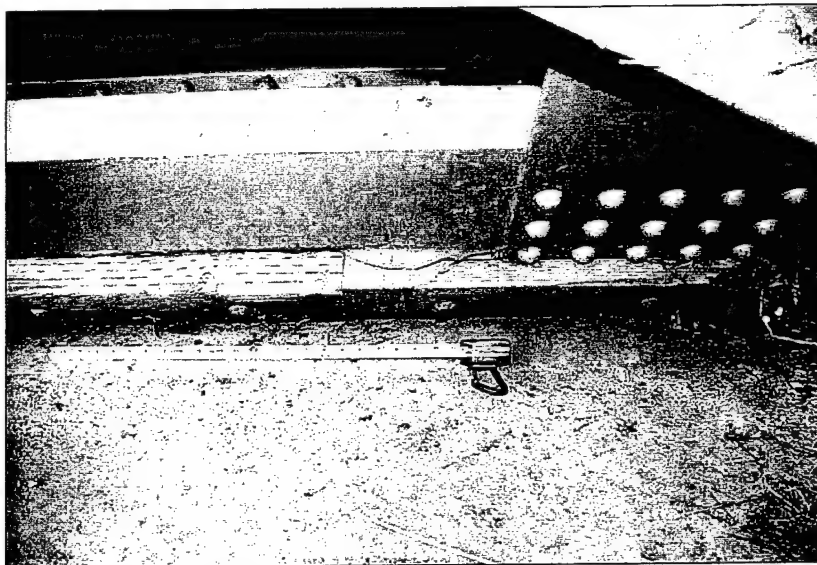
Timber bumpers are installed at the bottom of the gate on the downstream side. The timbers are bolted to the web of the bottom horizontal girder. At all of the gates, on at least one end, the timbers are split or deteriorated. See photo 15 below, typical.

Photo 15 - Splitting of bottom timber at right side (looking upstream) of Gate 1.

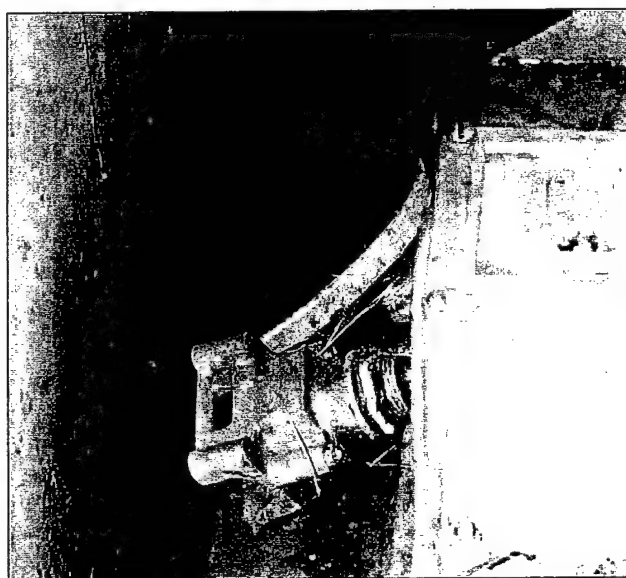
Electric side seal heaters have been installed on the gates at some time in the past. None of the operations personnel present were aware of the presence of the heaters. No determination as to the working condition of the heaters was made. See photo 16, below

Photo 16 - Apparent side seal heater, typical all gates.

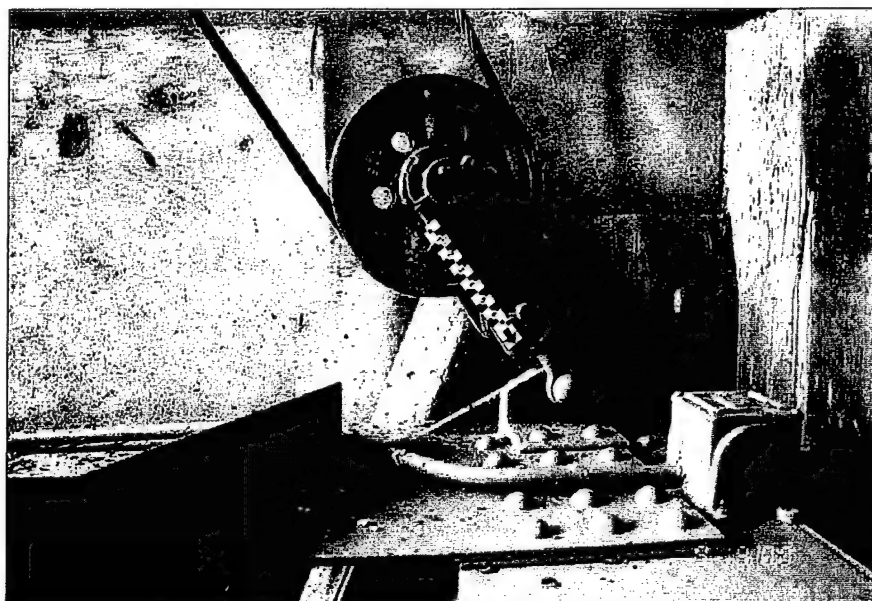
External portions of the hoist equipment, support platforms and gate connections were visually inspected for signs of excessive corrosion, wear or damage. The hoist and hoist machinery are in generally good condition. All of the gates were raised to approximately two feet open in order to check for racking and to allow access to the upstream side. Racking measurements were made at the left and right side of the gates, between the bottom corner of the bottom horizontal girder and the top of the spillway. There is no apparent racking occurring at any of the gates and all measurements were within 1/8-inch from one side to the other. Measurements for each of the gates are given in Table 1, below. The 2:1 reduction, lifting pulleys on the top of the gates were in good condition with only light corrosion on some of the wheels or linkages. See photo 17 below.

Photo 17 - Hoist reduction pulley at top of gate, typical.

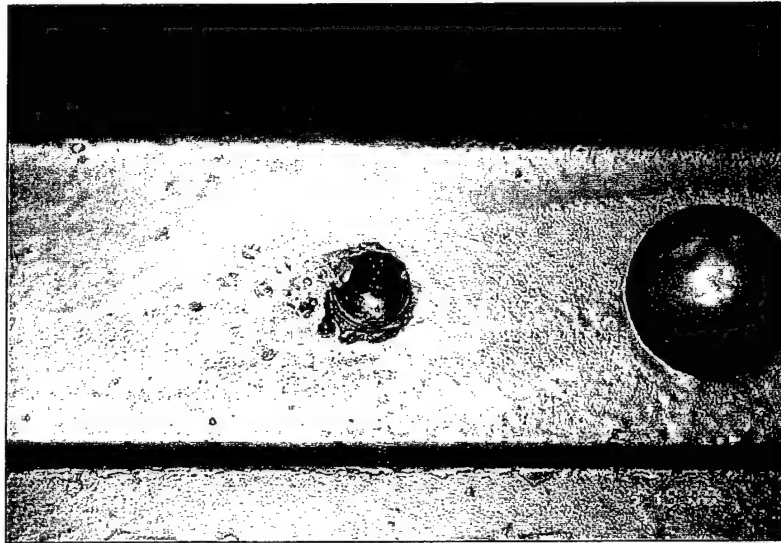
- There are two bolts missing between the top girder and the top seal. Some bolts appear to have been tack welded while others were not. One bolt was loose enough to turn by hand. See photo 20.

Photo 20 - Bolt at top girder to top seal. Note broken tack weld.

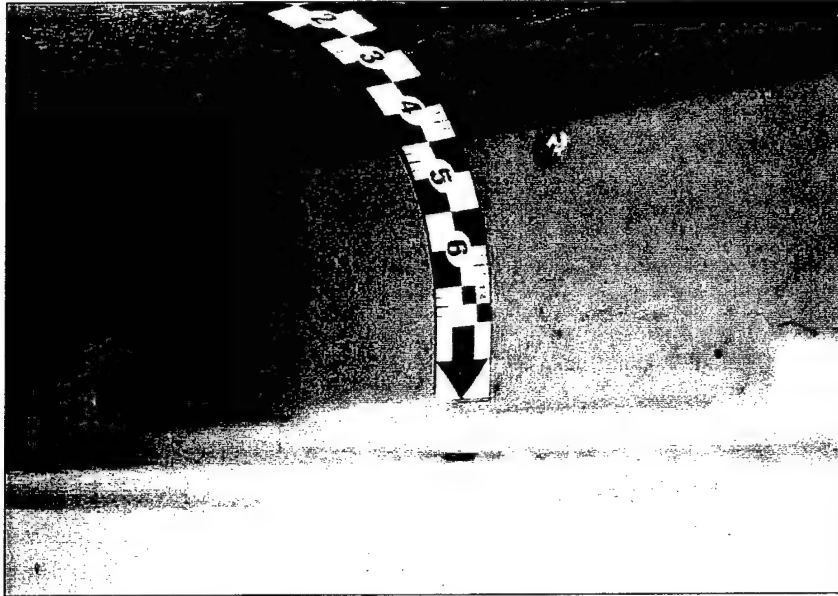
- There are five missing bolts at the top of the gate. The bolts attach the upstream top seal bracket to the skin plate and the web of the top horizontal channel. There is no apparent distress or evidence of leakage due to the missing bolts. See photo 22 below.

Photo 22 - Missing bolt at top seal bracket, typical of five locations. Note: presence of washer without bolt head.

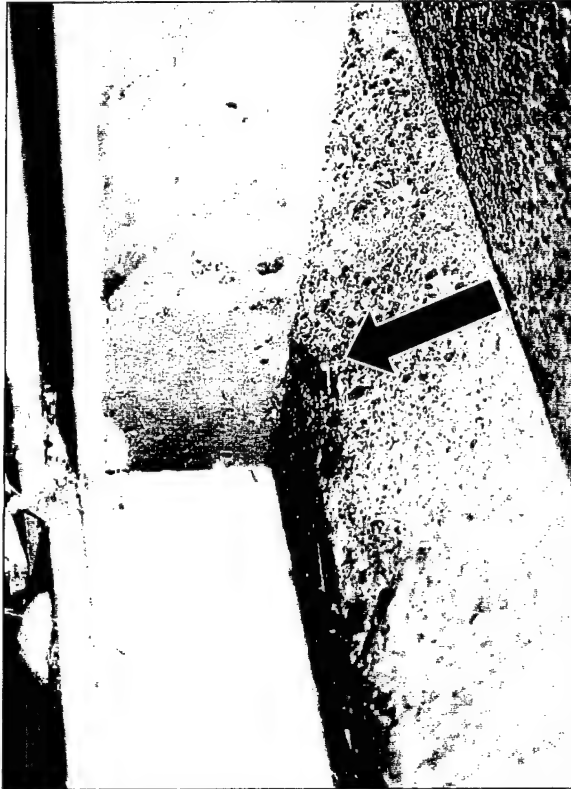
- The entire gate is shifted significantly to the right (looking upstream). The left side frame is in contact with the pier wall near the upstream end of the bottom radial strut. Scraping and gouging of the concrete pier is evident at the bottom of the pier. See photo 23.

***Photo 23 - Left frame in contact with pier wall.
Note: small steel ruler in gap between radial strut brace and concrete pier wall.***

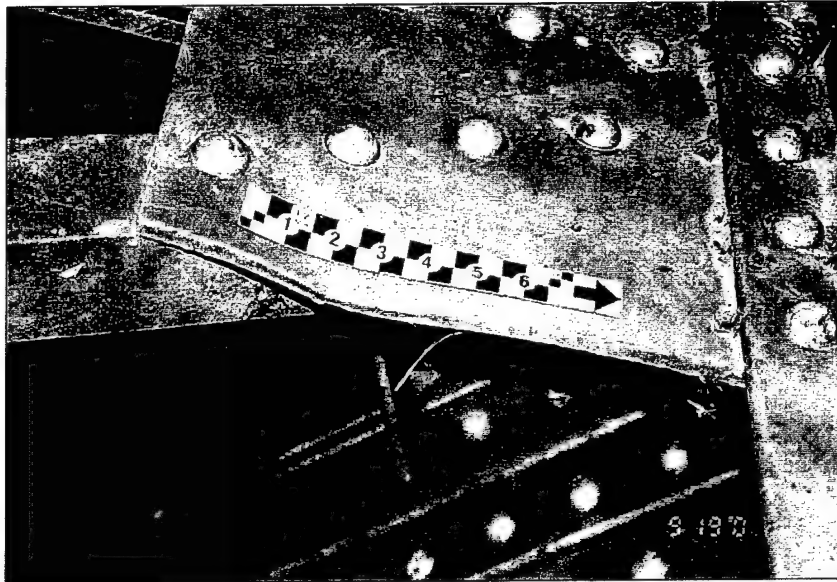
Riveted connections are in good condition with isolated spots of light corrosion. The gusset plate connecting the top left strut and top bracing to the top girder is deformed approximately $1/4$ -inch. See photo 25. It is unclear if this was caused by stress in the plate or something being dropped from above. The bolt holes at the connection of the top girder and the top seal have been flame cut to a slotted hole. This is typical across the top seal. See photo 26.

Photo 25 – Gusset plate at top strut connection to top girder.

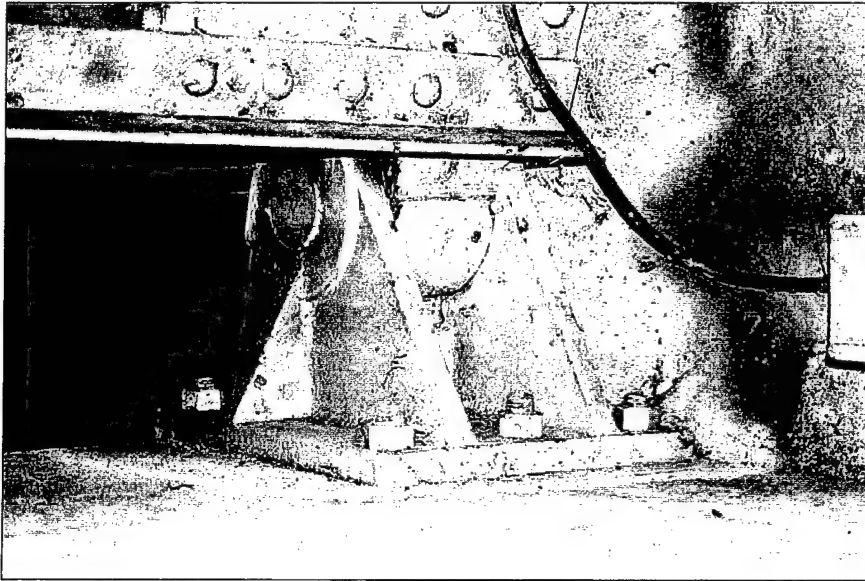
The trunnion consists of a 3-1/2 inch pin contained by a 1-1/2 inch thick bushing. All components of the trunnion are in good condition with only light surface corrosion at isolated locations. See photo 27.

Photo 27 – Left trunnion connection.

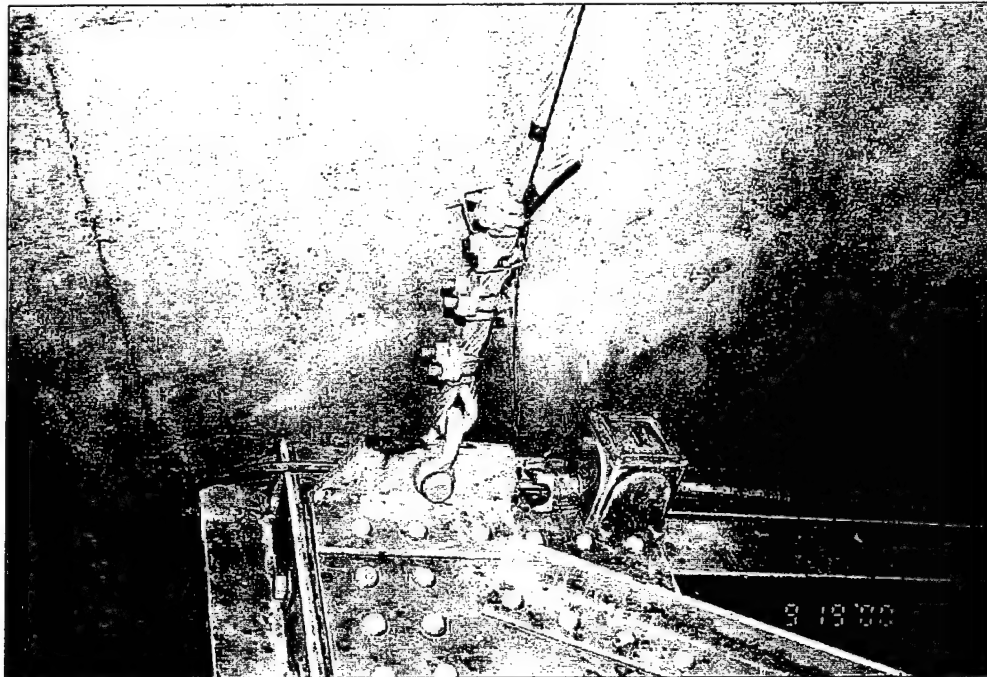
Electric side seal heaters have been installed on the gate at some time in the past. There is no indication of the heaters on the provided as-built plans. No determination as to the working condition of the heaters was made. See photo 28.

Photo 28 – Seal heater installed on gate.

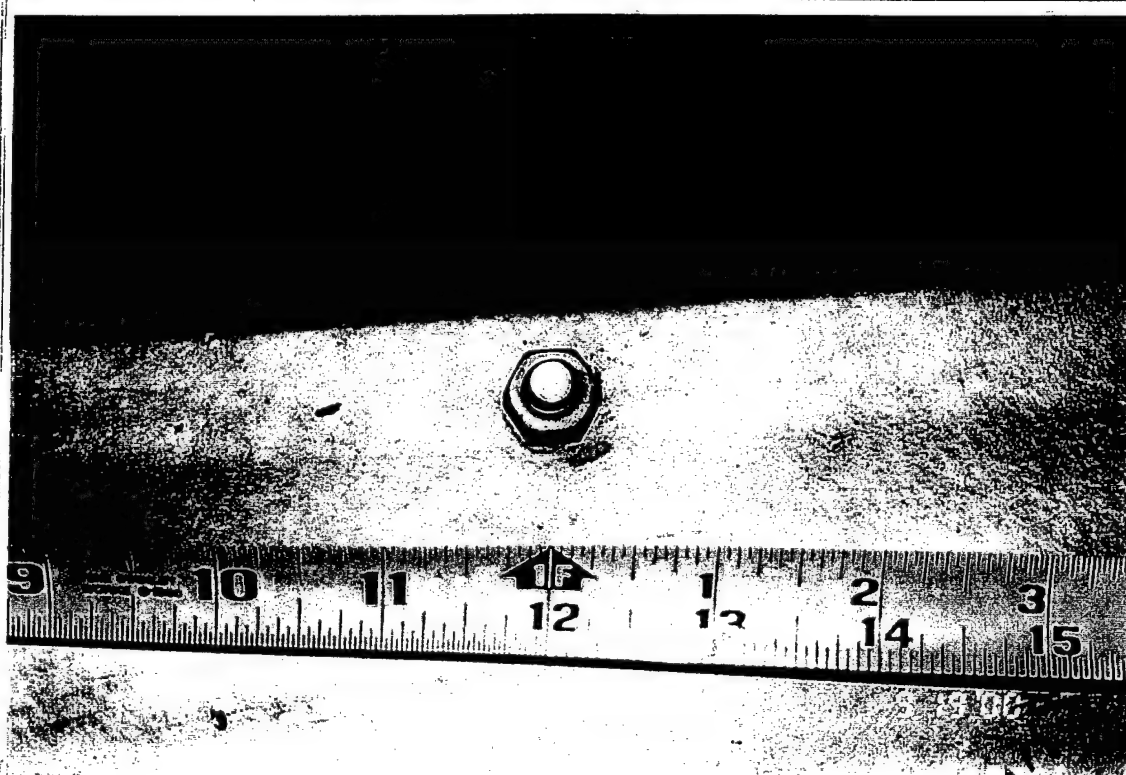
Mill Creek Dam 9/19/00 1-11	Armco 6'x14' Gate Bottom upstream end Strut 1, left side of gate. Light corrosion on gusset plate and bolts.
---	--

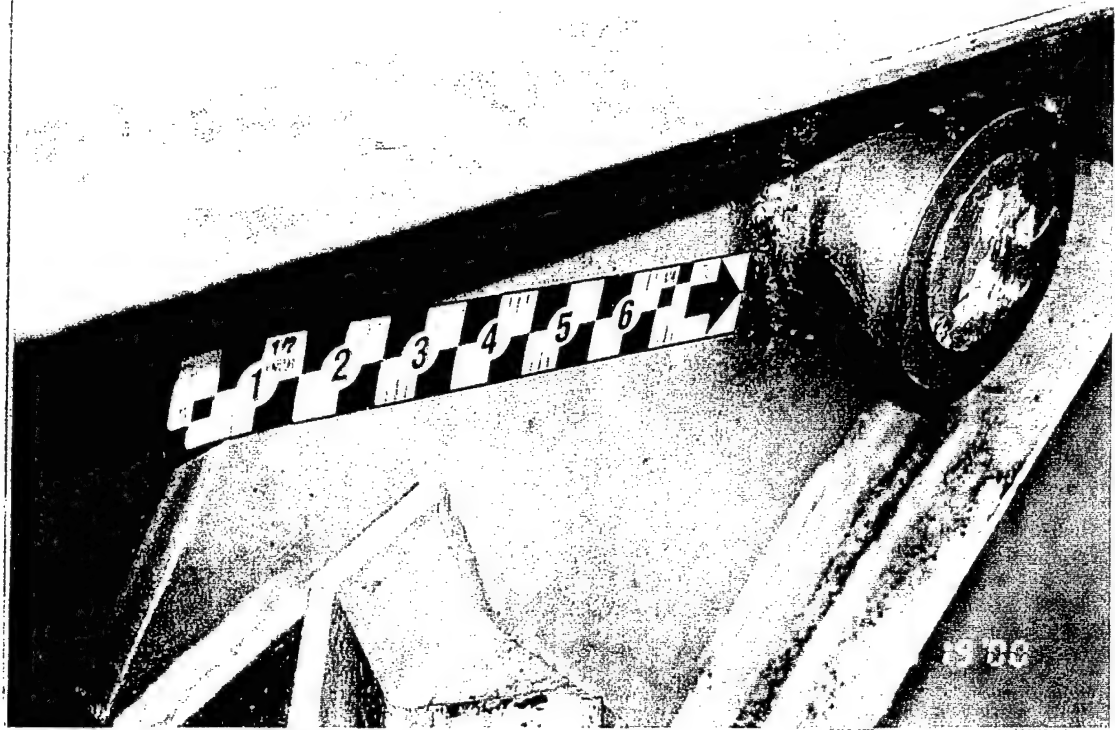
Mill Creek Dam 9/19/00 1-12	Armco 6'x14' Gate Typical condition of bolted connections.
---	---

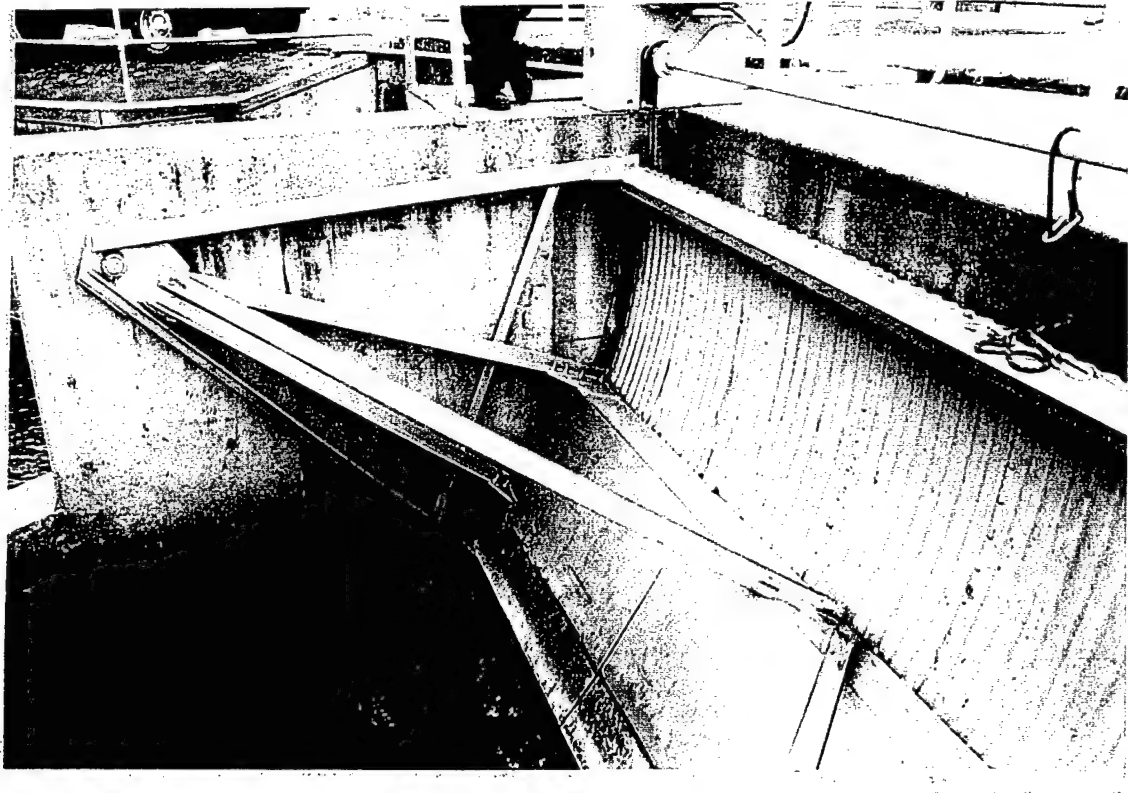
Mill
Creek
Dam
9/19/00
1-16

Armco 6'x14' Gate
Left trunnion looking downstream.
Light corrosion on embedded
trunnion assembly.

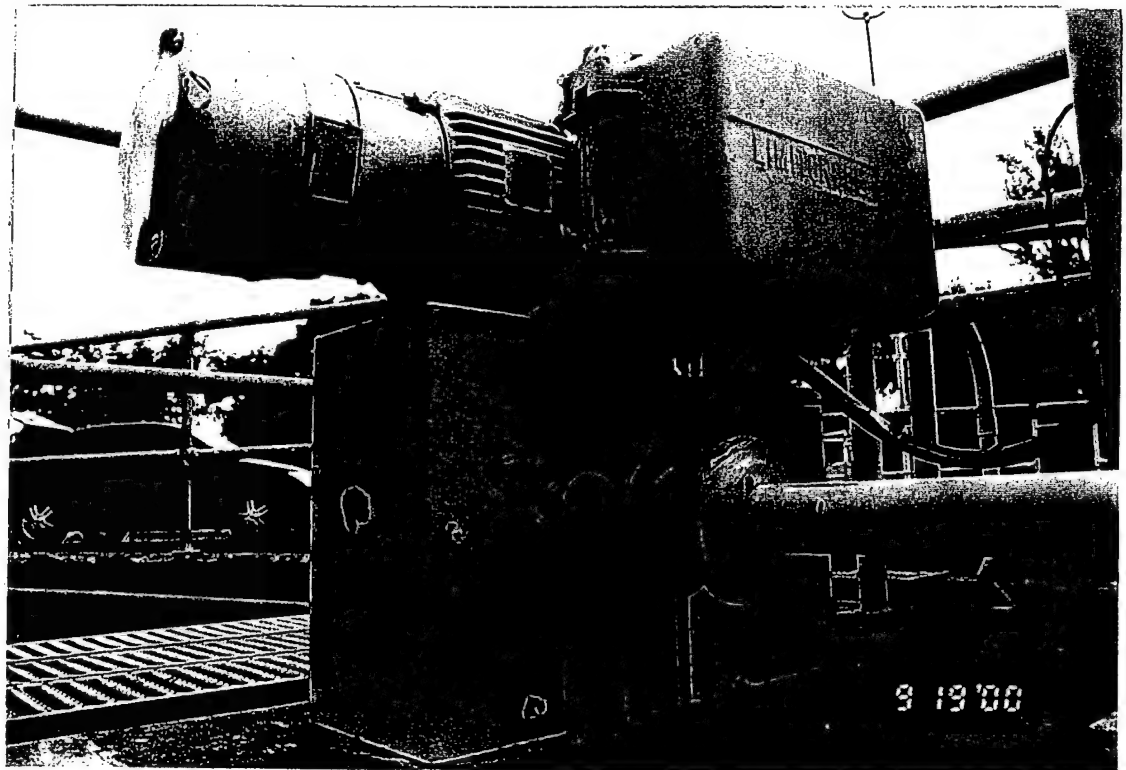
Mill
Creek
Dam
9/19/00
1-21

Armco 6'x14' Gate
Left side, hoist torque tube, support
bearing and take-up drum. Light
corrosion on drum.

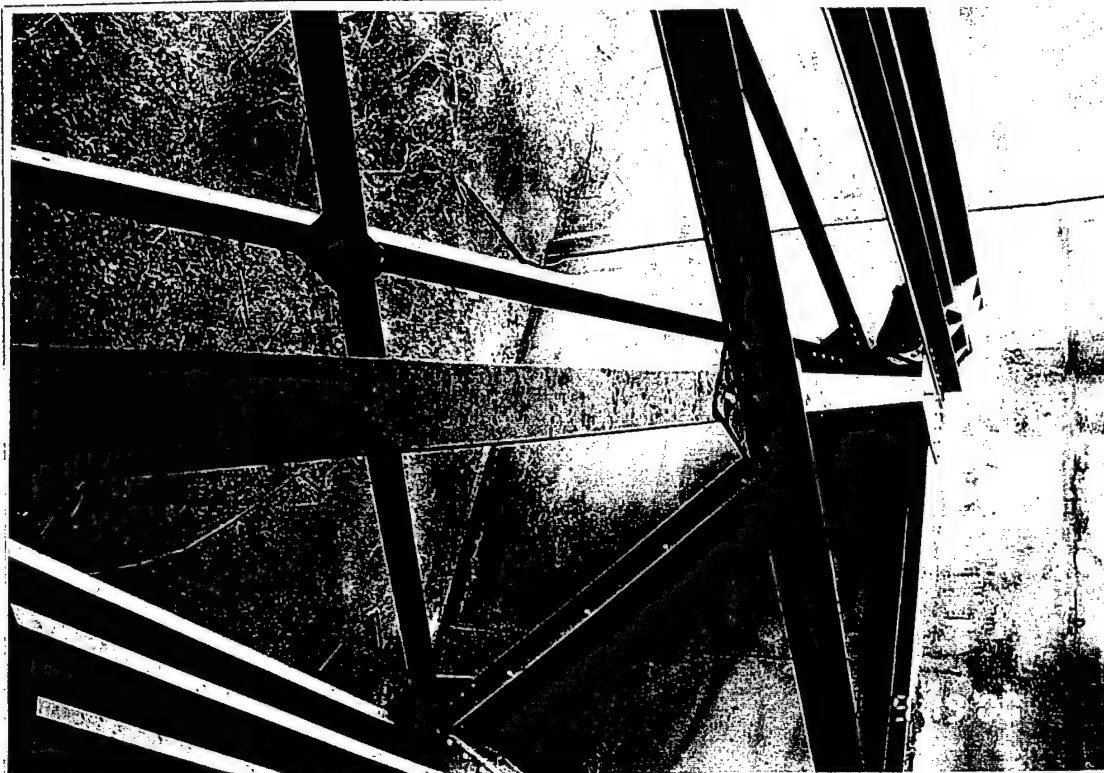
Mill
Creek
Dam
9/19/00
1-5

Gate 1 - 8'x18'
Top of top horizontal girder and right
hoist reduction pulley. Note: missing
paint on pulley at previous location of
hoist connection

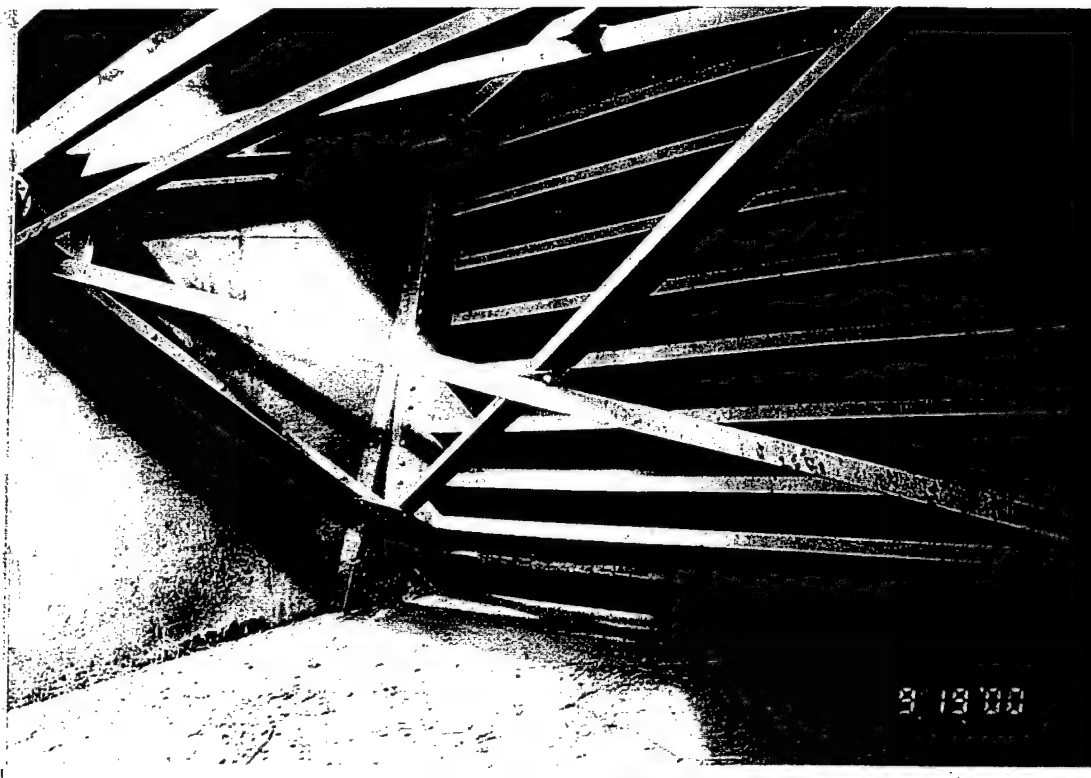
Gate 1 - 8'x18'
Bottom right corner of gate. Light to
moderate corrosion and deformations
on bottom strut. Splintered timber
bottom seal bumper.

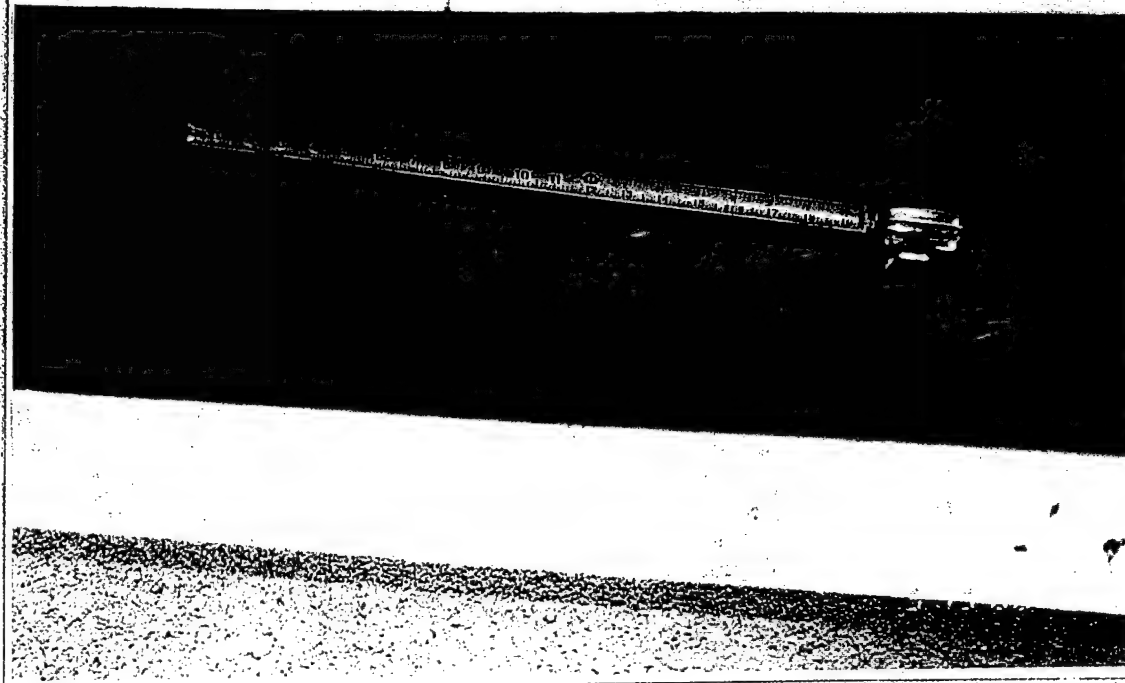
Gate 2 - 8'x18'
Close-up, bottom left side of gate at
timber bumper. Splitting at end of
bumper, light to moderate corrosion
on bottom strut.

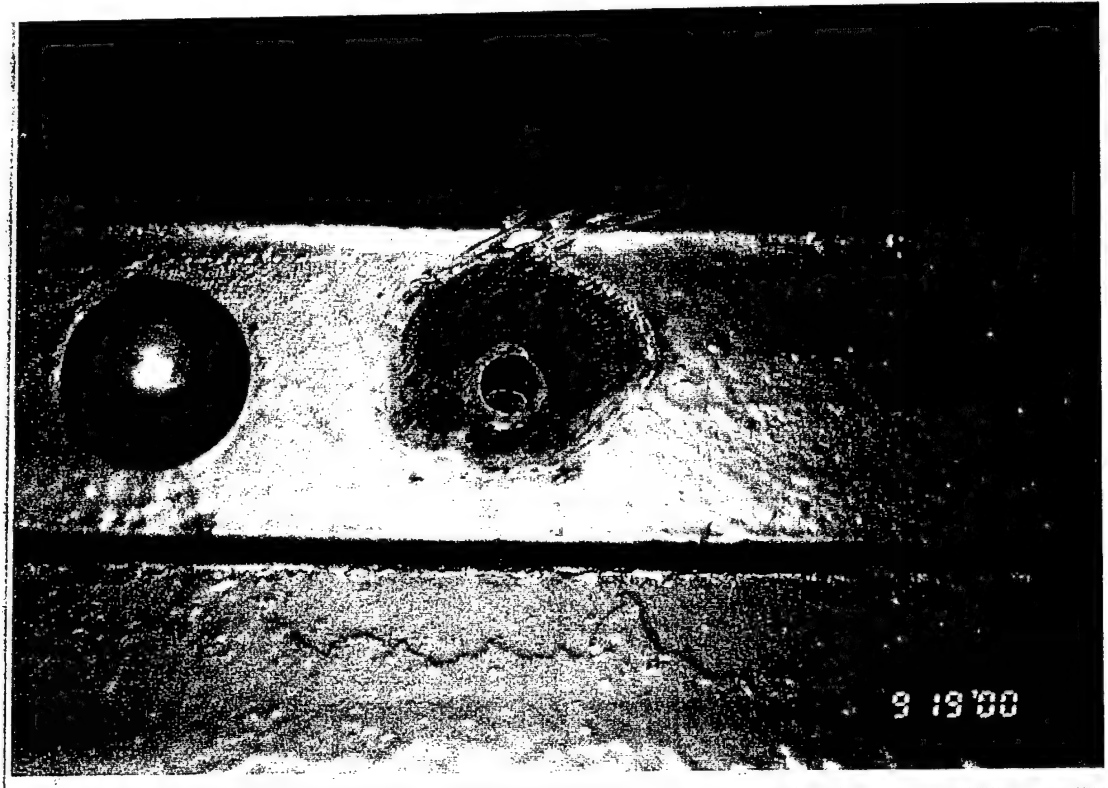
Mill
Creek
Dam
9/19/00
3-8

Gate 3 - 8'x18'
Top seal angle connection bolts,
approximately center of gate. Bolt is
loose and can be turned by hand.

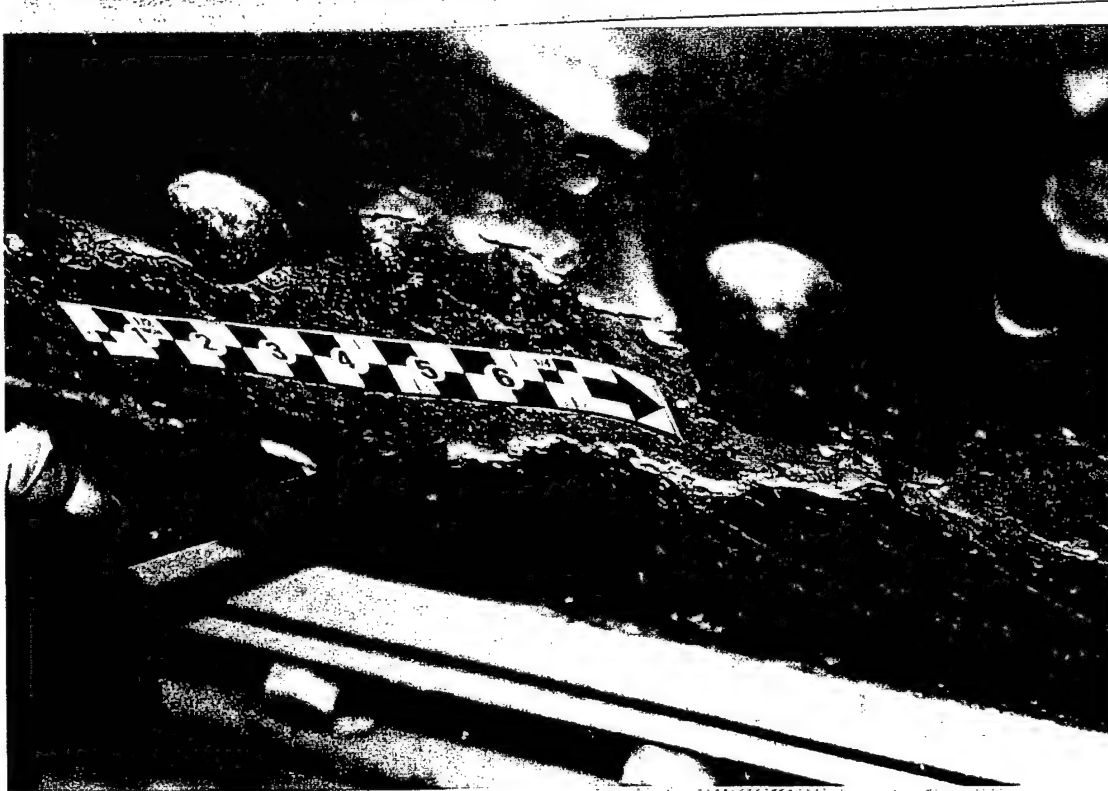
Gate 3 - 8'x18'
Close-up of skin plate at bottom seal.
Light to moderate corrosion.
